**Locating Contamination Plumes near Mount Mckay Waste Disposal Site**

Discipline: Civil Engineering - Environmental Engineering

Date Submitted: 17 April, 2023

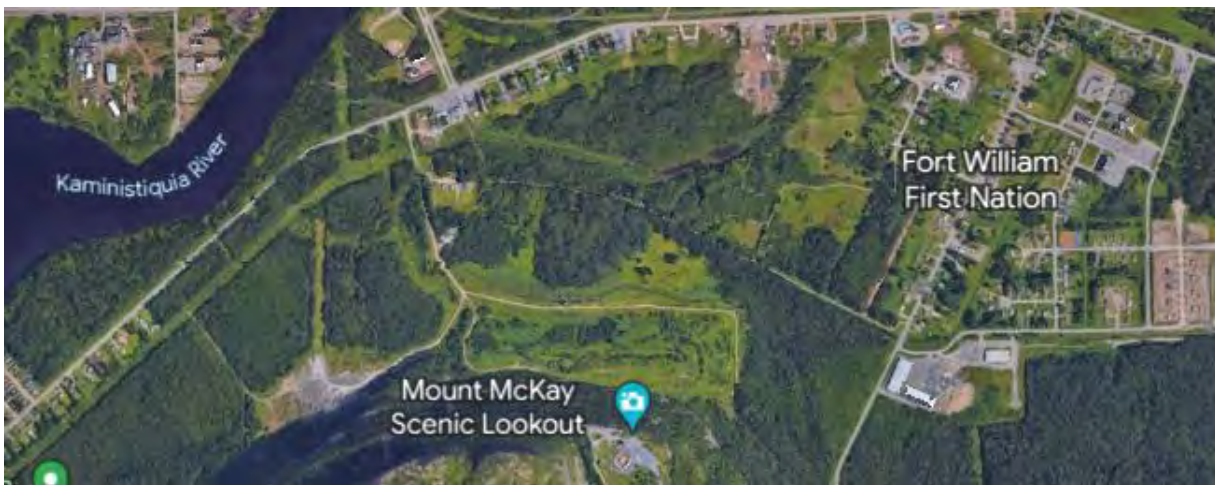
*Figure 1: Waste Disposal Site*

The impact of the Avenor Inc. Pulp and Paper Mill on air quality and the company's long-term operation of a waste disposal site near First Nation territories were two significant environmental concerns raised by the First Nation. The mill lies across Highway 61B from the community, in the northeast. A bark and ash waste disposal facility run by the mill is located next to the community. The dumping site is situated at the northern edge of the Fort William First Nation Reserve, at the foot of Mount McKay. The Reserve borders the majority of the site. The 11-hectare lot is right next to its western boundary (purchased in 1994 by Avenor from the City of Thunder Bay). This parcel does not form part of the waste disposal site. The Department of National Defense Rifle Range is adjacent to this site. Access to the landfill is via Highway 61B. (Bosgoed Project Consultants Ltd., 1996)

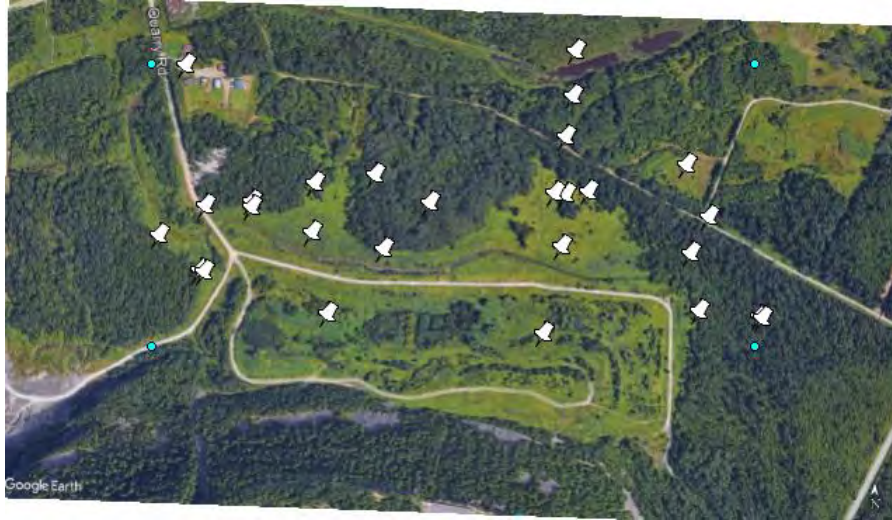
Figure 2: Aerial Photograph with Digitized Monitoring Wells

First of all, Google Earth Pro was used to export the aerial photograph for the reference of the area around the Mount McKay Waste Disposal Site where the monitoring wells were situated. A snapshot of the aerial picture of the area was taken along with the four corner coordinates for the reference. Then, the approximate coordinates of the monitoring wells were estimated in Google Earth Pro to digitize them and the coordinates were recorded.
