Phase II Environmental Site Assessment First Nations, Thunder Bay, Ontario

School of Applied Technology, Humber College

Civil Engineering Technology

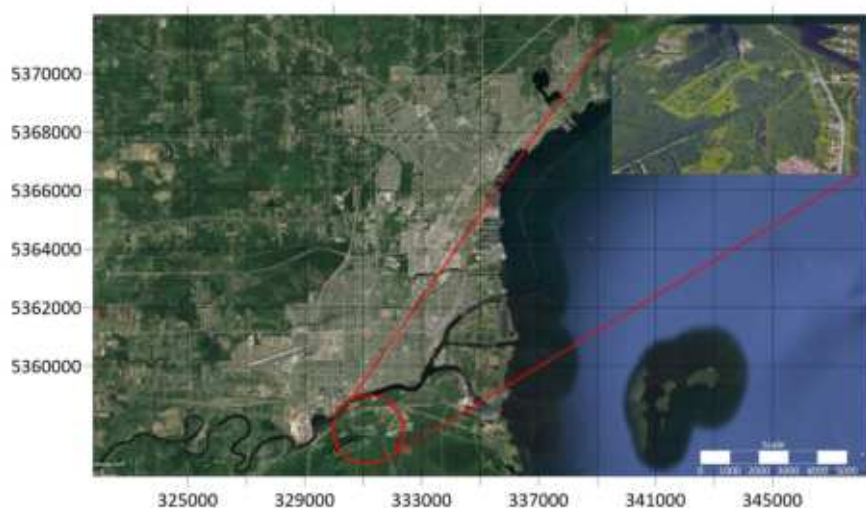
Figure 1. General Overview Thunder Bay, Ontario, Canada, image taken from Google Earth, 2023 and modified in Surfer Golden Software to show the designated area for waste disposal.

The bark dump is an area of 14.18 hectares located in Thunder Bay, Ontario, northeast of the First Nation's community, across Highway 61B (base of Mt. McKay), and it was used as waste disposal for 7 years. According to Bosgoed Project Consultant (1996), the bark dump is composed of 5200 m³ (4%) of wastewater treatment sludge, 6500 m³ (5%) of coil (boiler) ash, 11700 (9%) of lime mud, 11700 (9%) miscellaneous yard debris and construction rubble, 42900 (33%) of reactor ash and 52000 (40%) of bark and wood waste and covered in 1980s. Figure 1 shows the designated area for waste disposal. The landfill has a configuration with the highest elevation measured at the top of 229.113 metres and the lowest elevation measured 189.100 metres as shown in Figure 2.

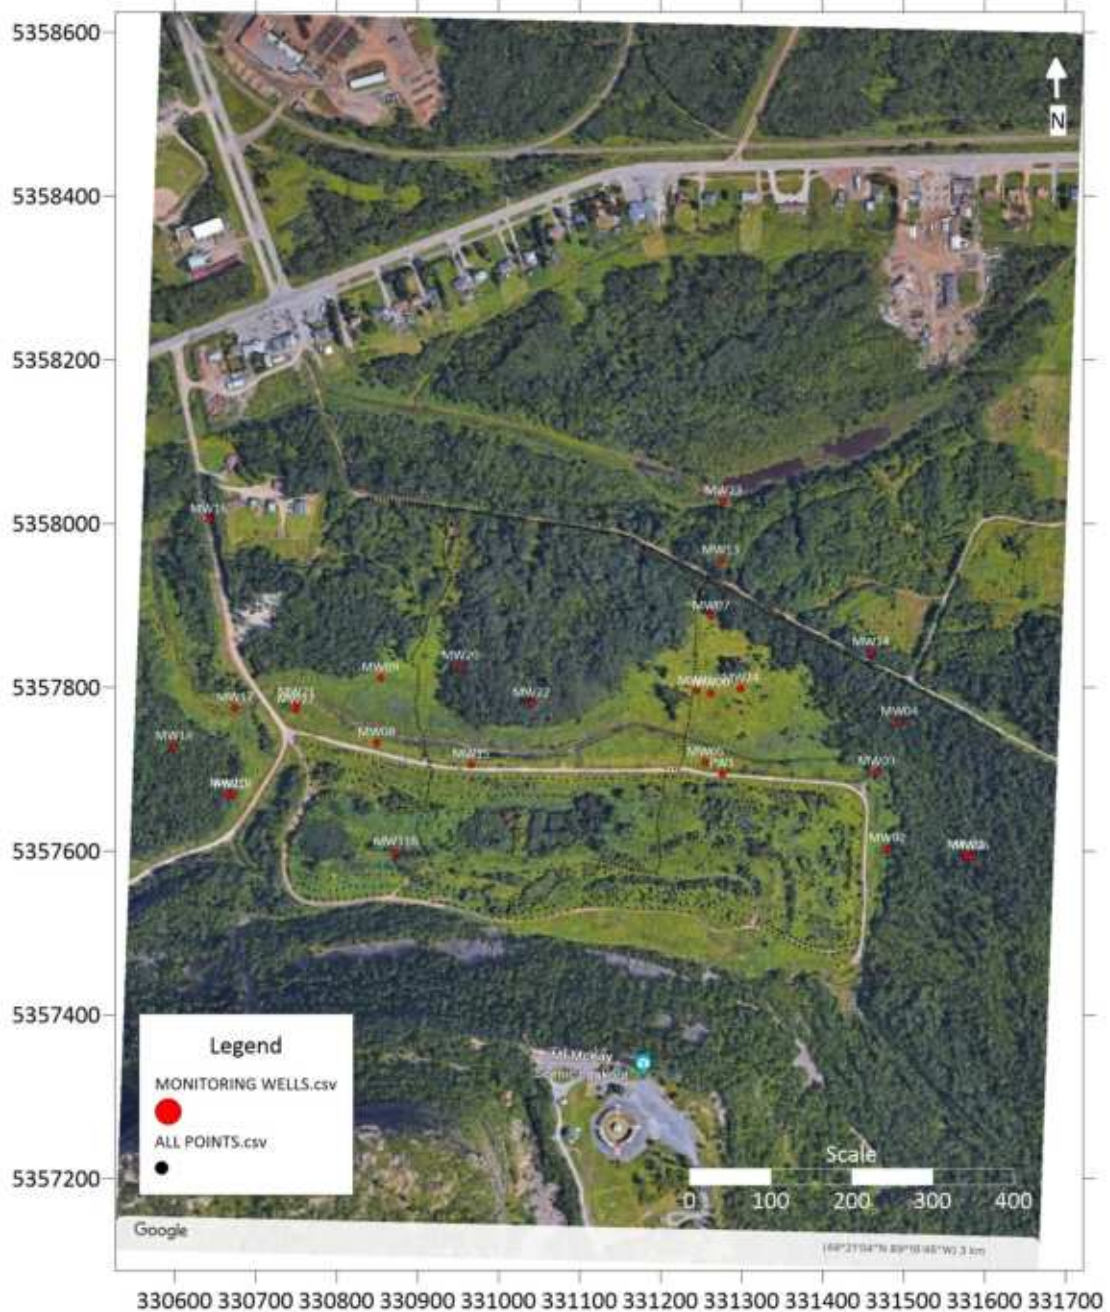
Figure 3. Overview of the monitoring wells bark dump, Google Earth, 2023 and modified in Surfer Golden Software.

According to Trevisan & Oshki-Aki LP, (2021), the bark dump is monitored using the existing monitoring wells, as the location shown in Figure 3, MW01, MW02, MW03, MW04, MW05, MW06, MW07, MW08, MW09, MW10, MW11R, MW13, MW14, MW15, MW16, MW17, MW18, MW19, MW20, MW21, MW22, MW23, MW24, MW25, MW26, MW27, PW1. The red points on Figure 3 represent the existing monitoring wells and the black points represent the topographic points collected in site

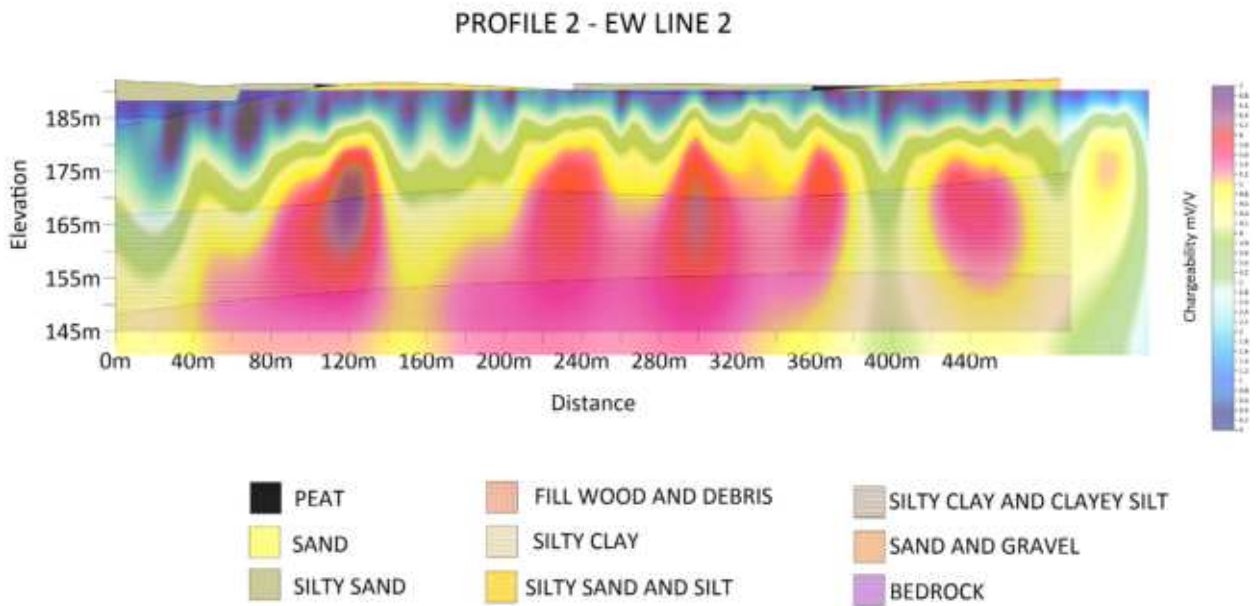
Figure 10. Chargeability Line 2.

- AC-EW2-1: The area of concern EW2-1 presents with high values for resistivity and chargeability. The centre of the area is located 120 metres from the beginning and has an average elevation of 170 metres. The area has, approximately, a length of 129 metres and a depth of 35 metres. The composition of the soil in this area is silty clay, silty sand and silt.
- AC-EW2-2: The area of concern EW2-2 presents with the same characteristics as EW2-1 for resistivity and chargeability. The centre of the second area of concern is located 360 metres from the beginning, with an average elevation of 170 metres from the surface. The area has, approximately, a length of 353 metres and a depth of 31 metres. Along the areas of concern, the layers are composed of silty clay and clayey silt and silty sand and silt.

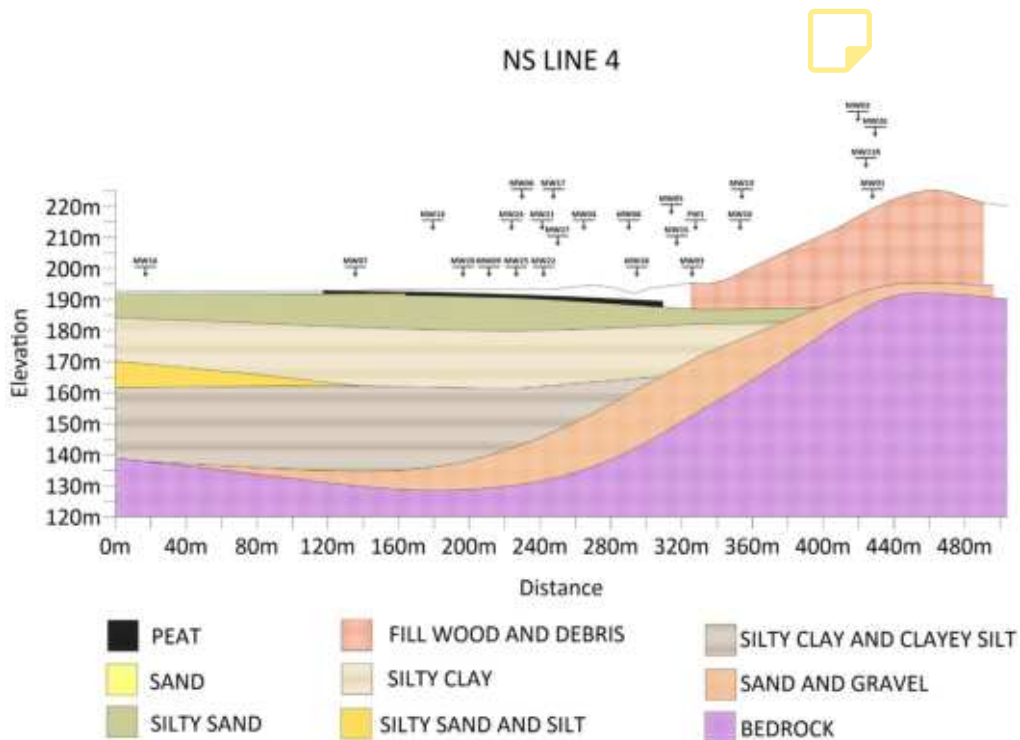
Figure 14. Stratigraphy of the soil Line 4.

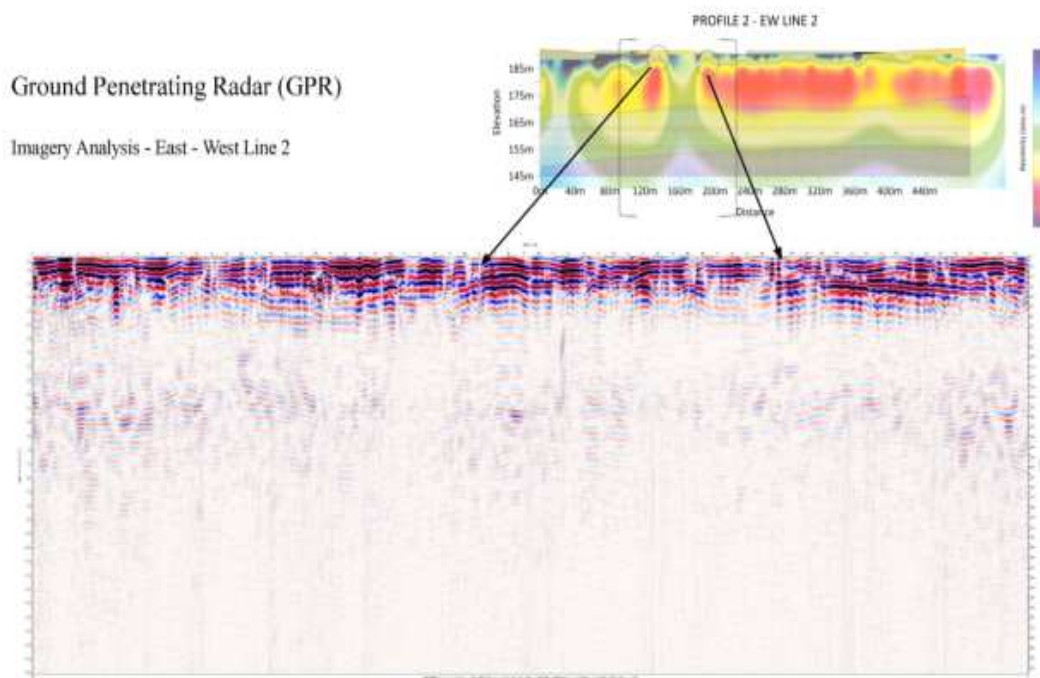
Figures 23, 24 and 25 show all points of possible pockets of VOC along Line 2. The GPR shows a non-consistent area of deflection that according to Jacome et al., (2021) is related to voids into the soil.

Figure 23. Local interpretation of resistivity of the area of concern AC-EW2-1.

Figure 24. Local interpretation of resistivity of the area of concern AC-EW2-2.

Figure 25. Local interpretation of resistivity of the area of concern AC-EW2-2.

The analysis of the GPR and the resistivity at line 2 and line 3 suggests a potential presence of gases trapped by the silty sand and silt layer, which may indicate a biodegradation of organic matters. The analysis of the GPR at line 2, presents with many different points of discontinuous signals originating from the GPR as showed in the figure GPR - LINE 2 93.2 to 226.2 metres, GPR - LINE 2 226.2 to 294.2 metres and GPR - LINE 2 294.2 to 444.2 metres, and the analysis of line 3, presents with a point of discontinuity at GPR - LINE 3 195.2 to 214.2

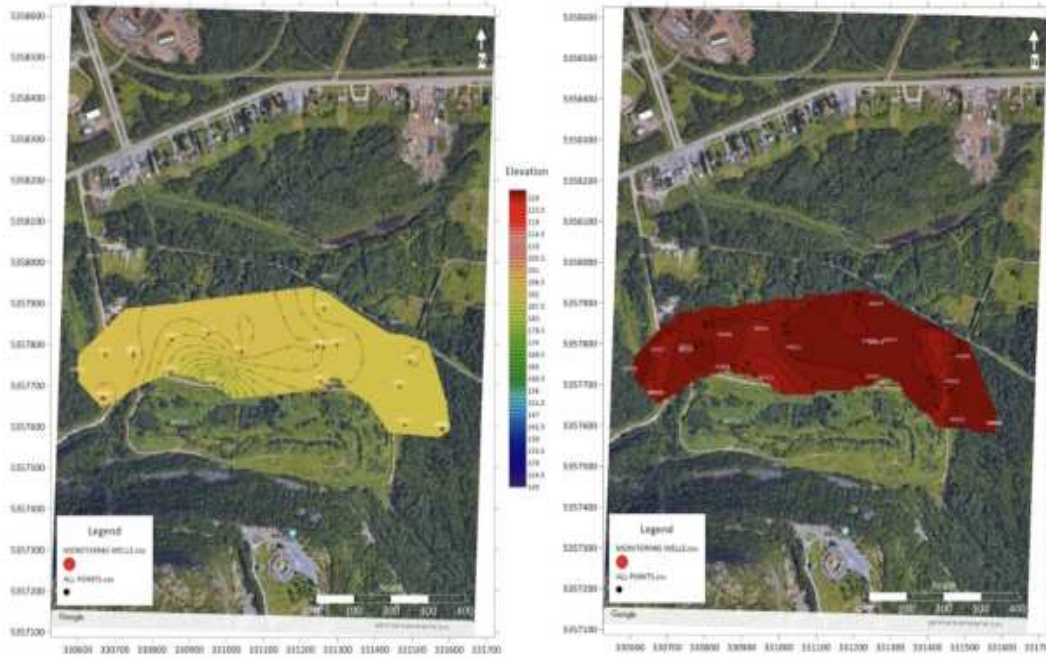
Figure 57. In the left, the contour map and in the right isopach map of the layer peat.
